TEST RECORD

NO. 2315.2100744.0352

Traction fuse CC1000D73L301.800I,
Traction fuse 6001000

Verification of the breaking capacity at 970 V DC and 100 kA

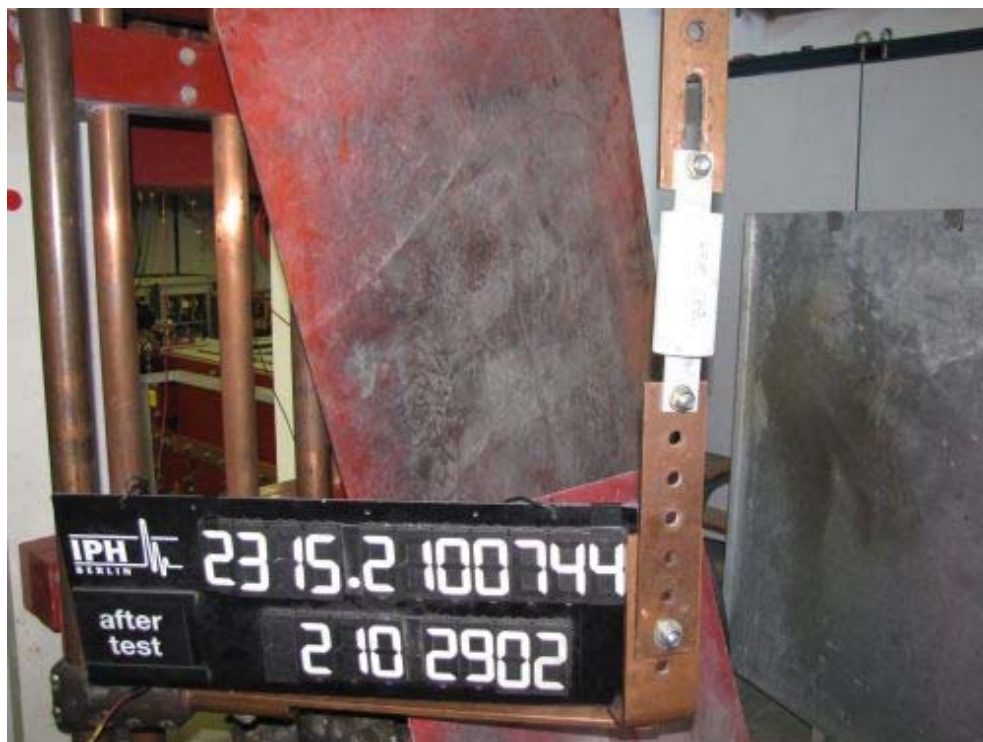
Photo 1: Test object No. 3 after test

| Oscillogram No. | | 2102901 | 2102902 | 2102903 | 2102904 |
|---|---|---|---|---|---|
| No. of test object | | - | 3 | 5 | 8 |
| Evaluation | | - | OK | OK | OK |

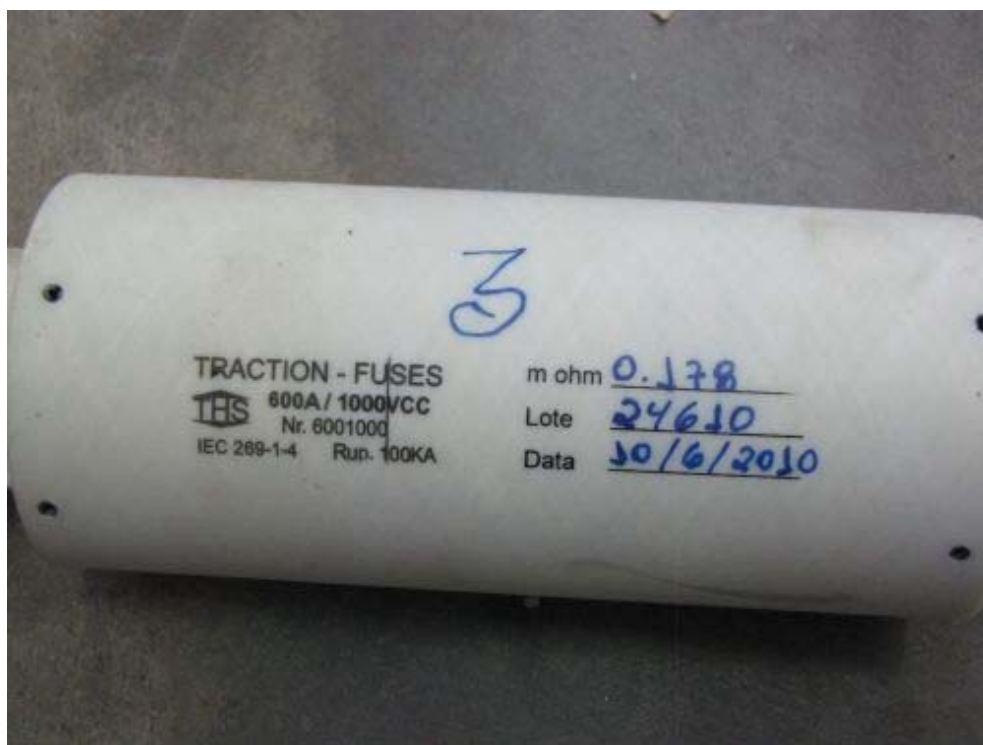
Photo 2: Test object No. 3 after test

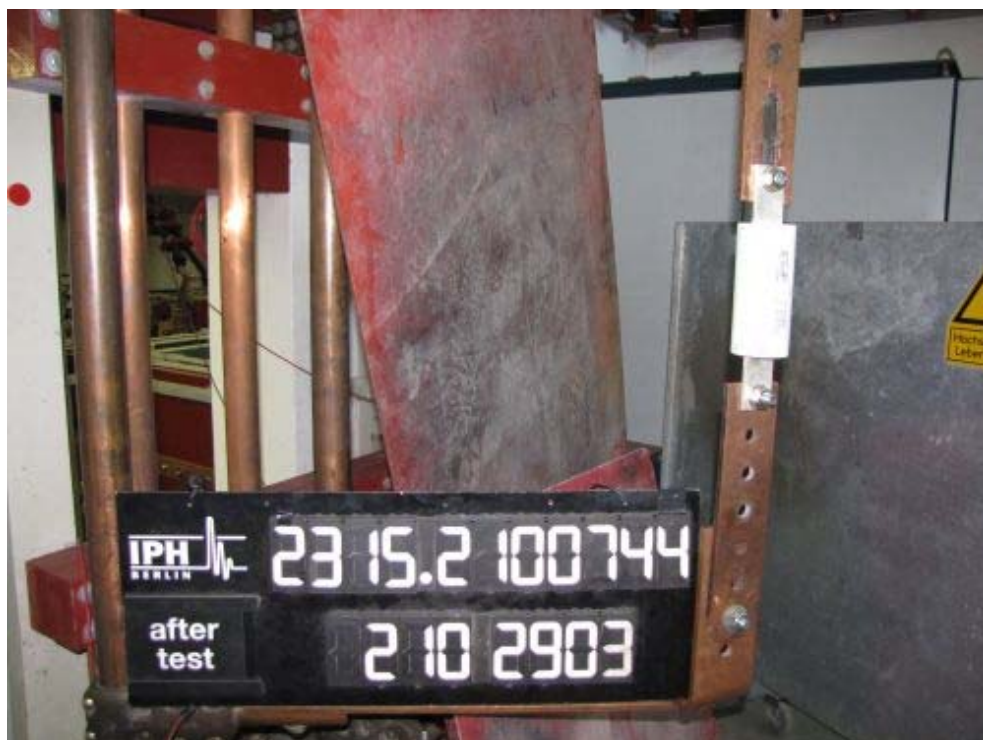
Photo 3: Test object No. 5 after test

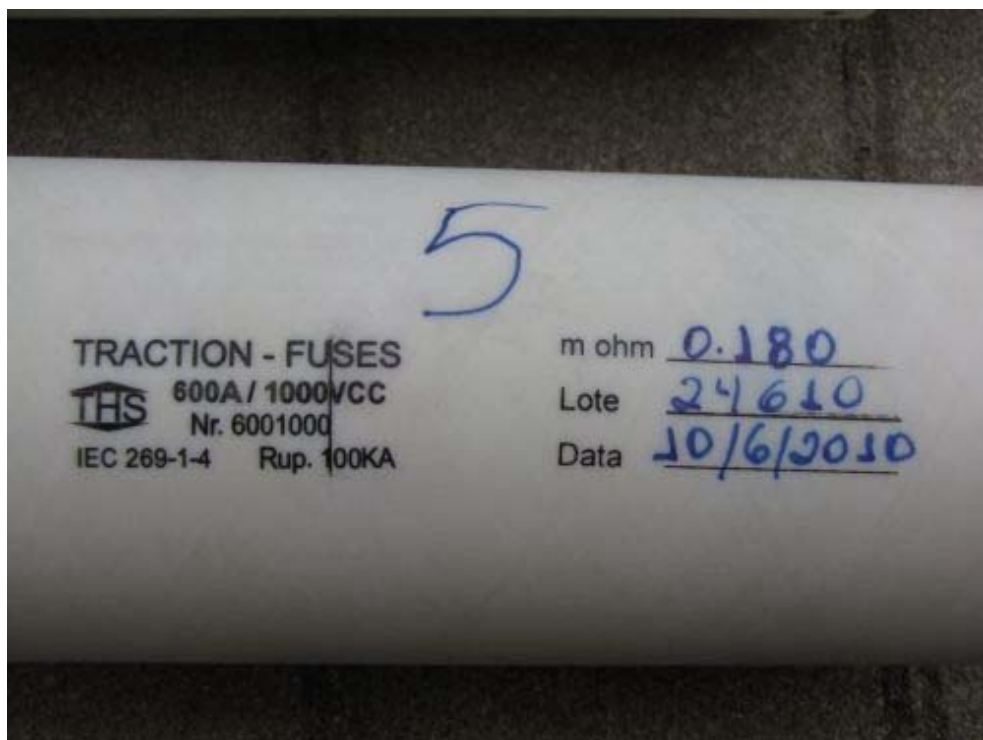
Photo 4: Test object No. 5 after test

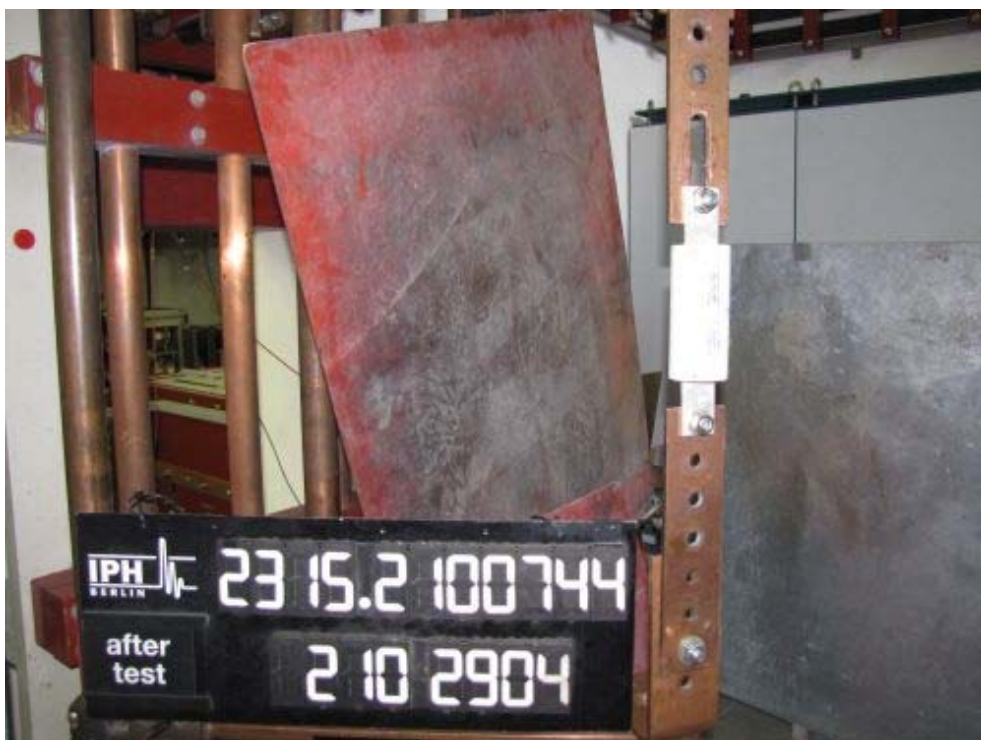
Photo 5: Test object No. 8 after test

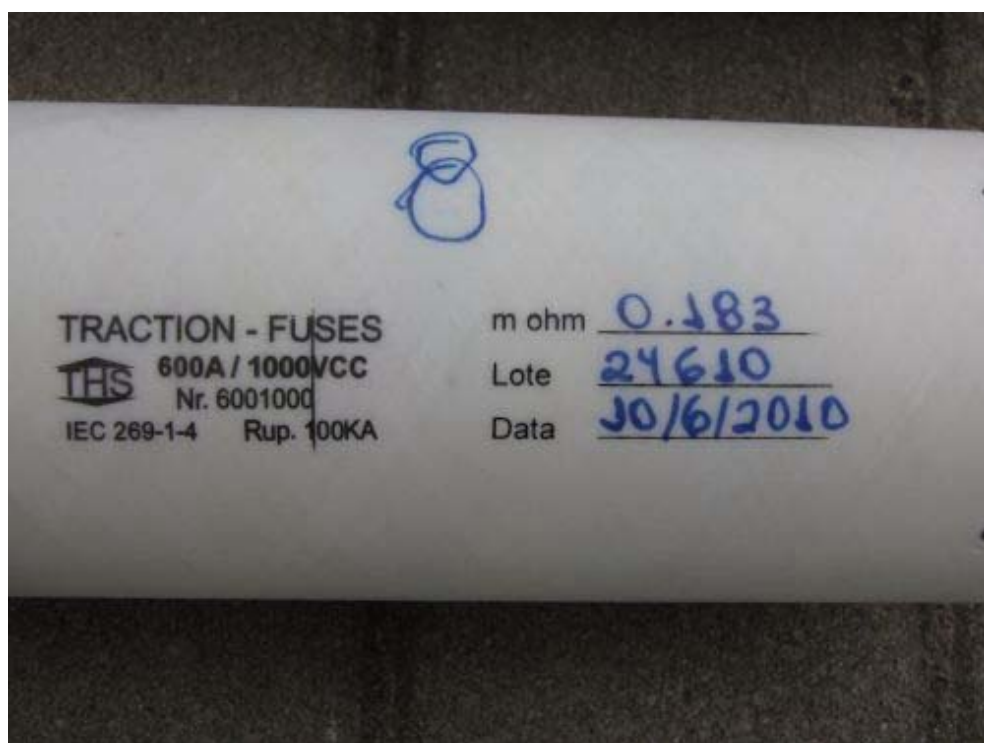
Photo 6: Test object No. 8 after test

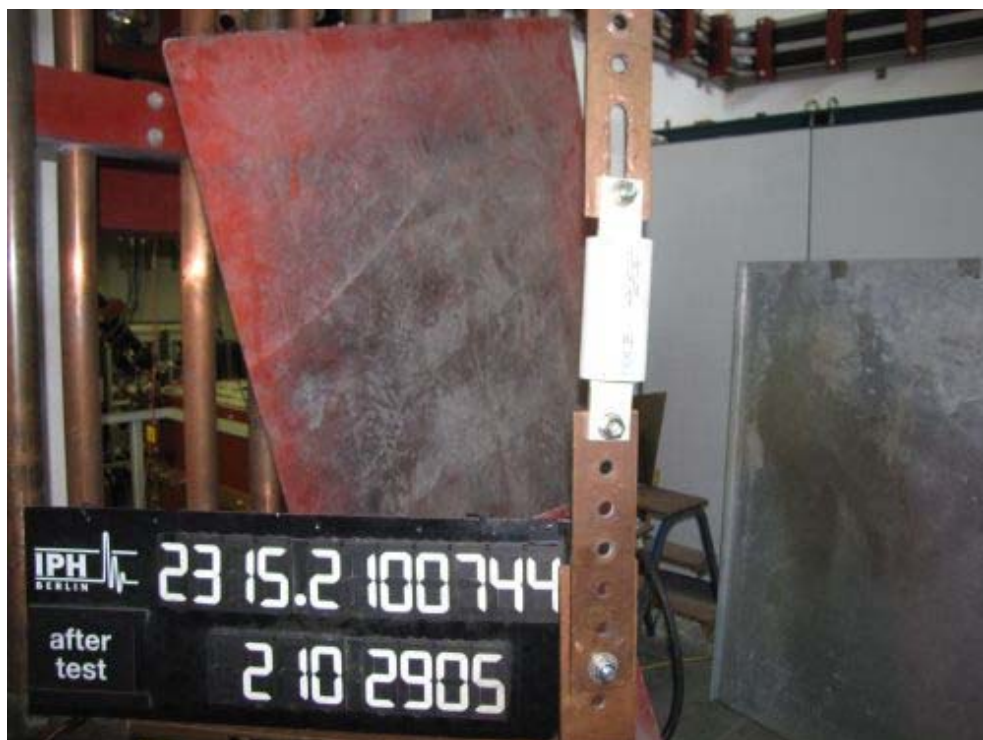
Photo 7: Test object No. 21 after test

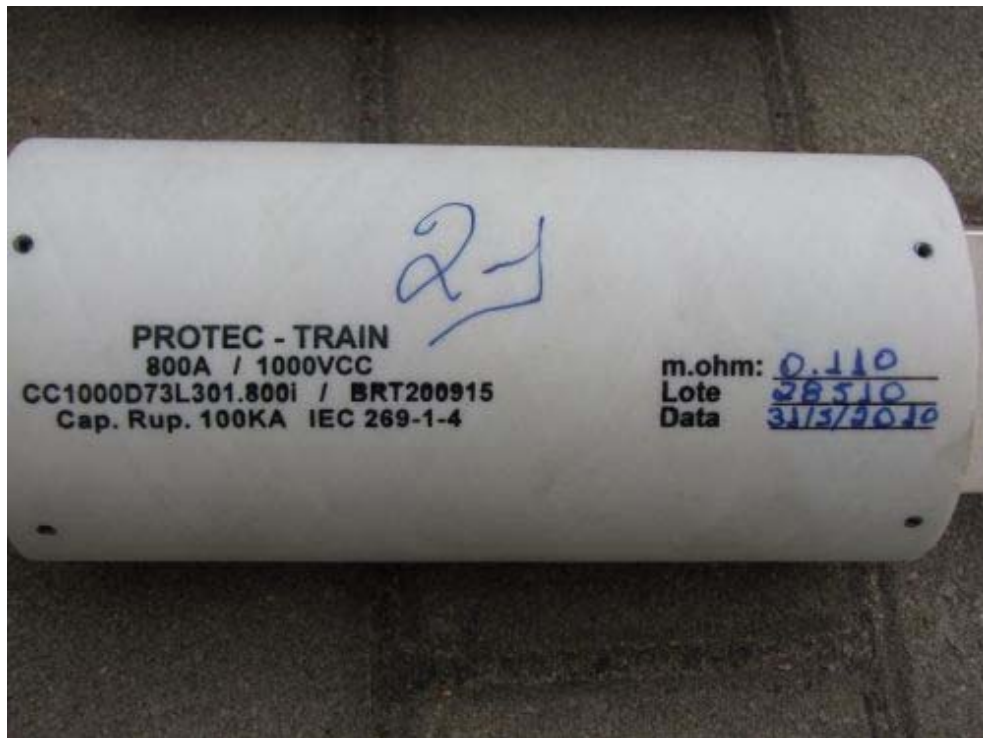
Photo 8: Test object No. 21 after test

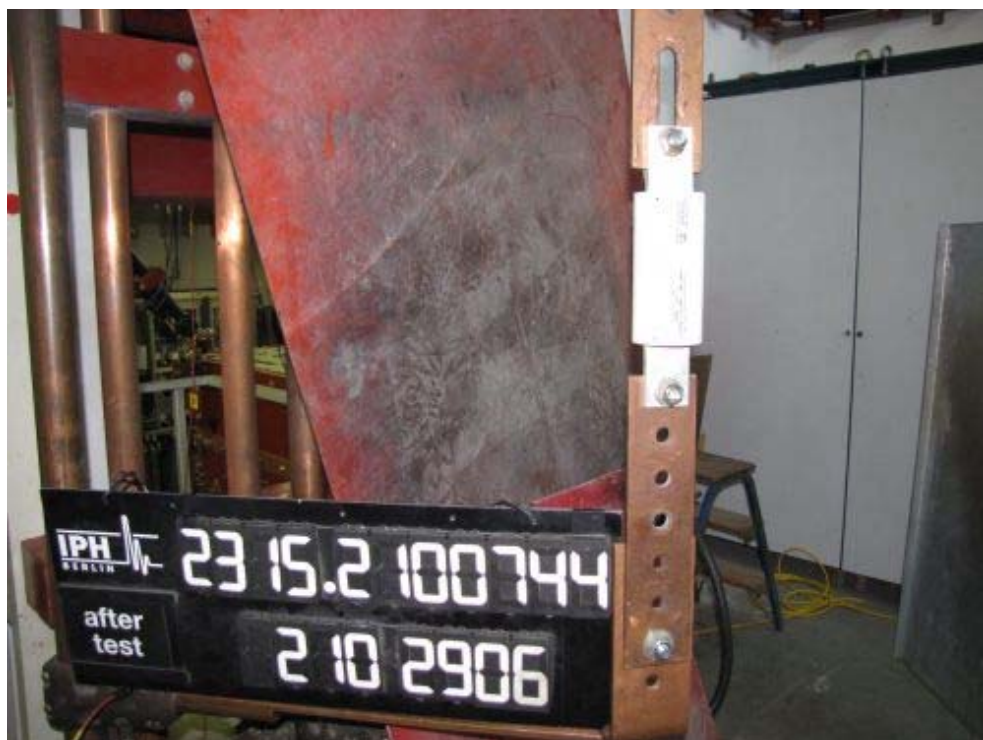
Photo 9: Test object No. 22 after test

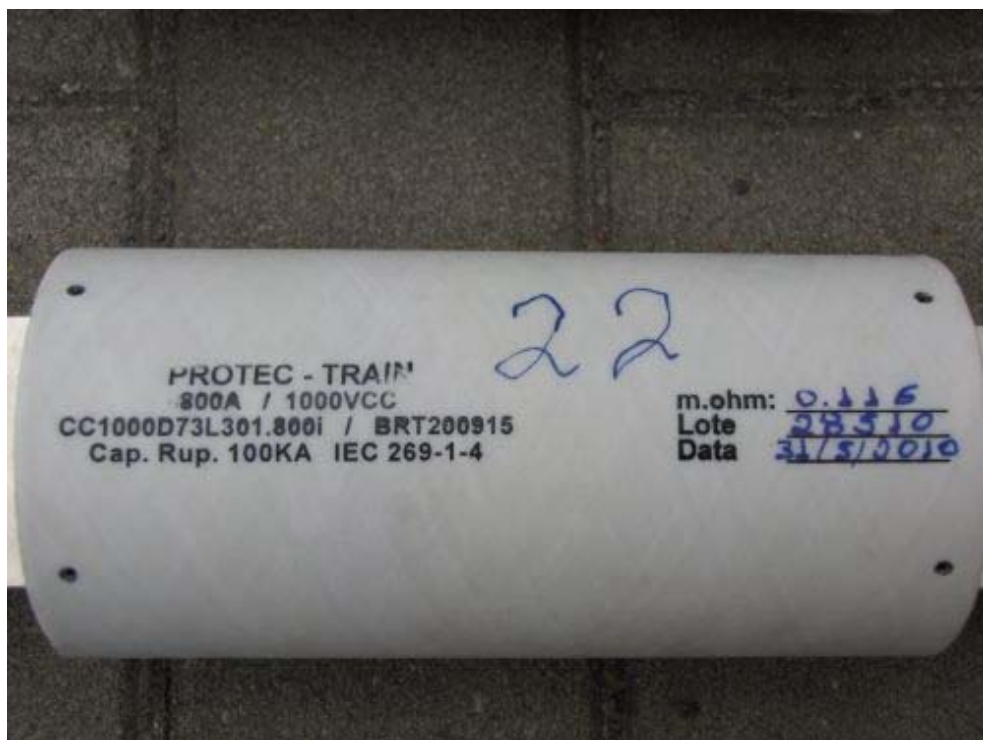
Photo 10: Test object No. 22 after test

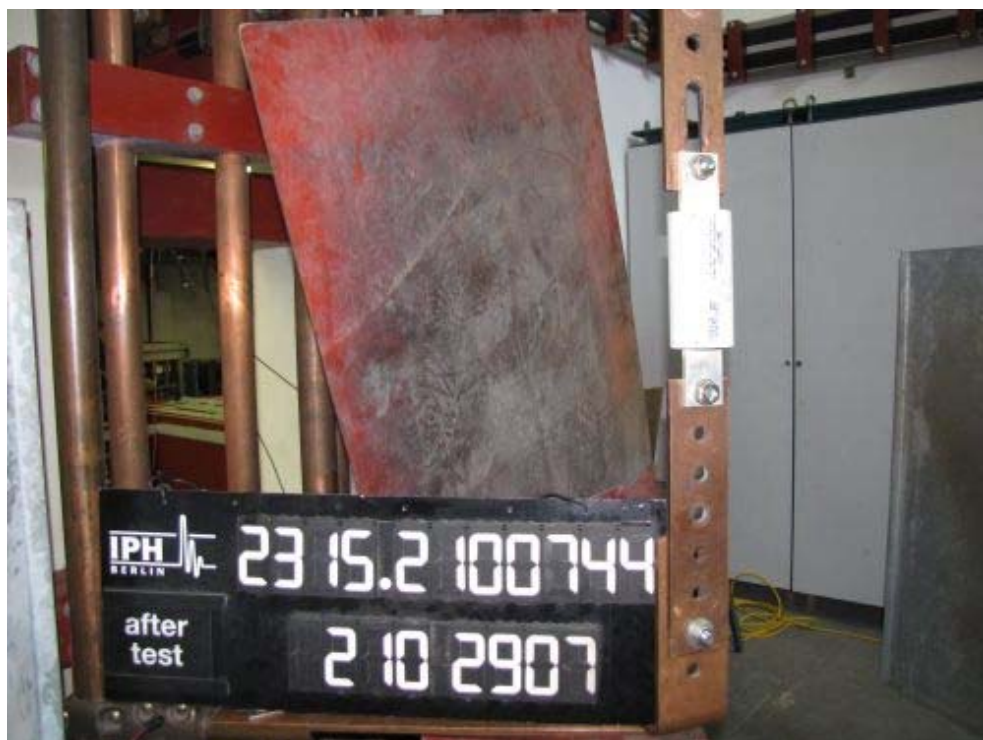
Photo 11: Test object No. 23 after test

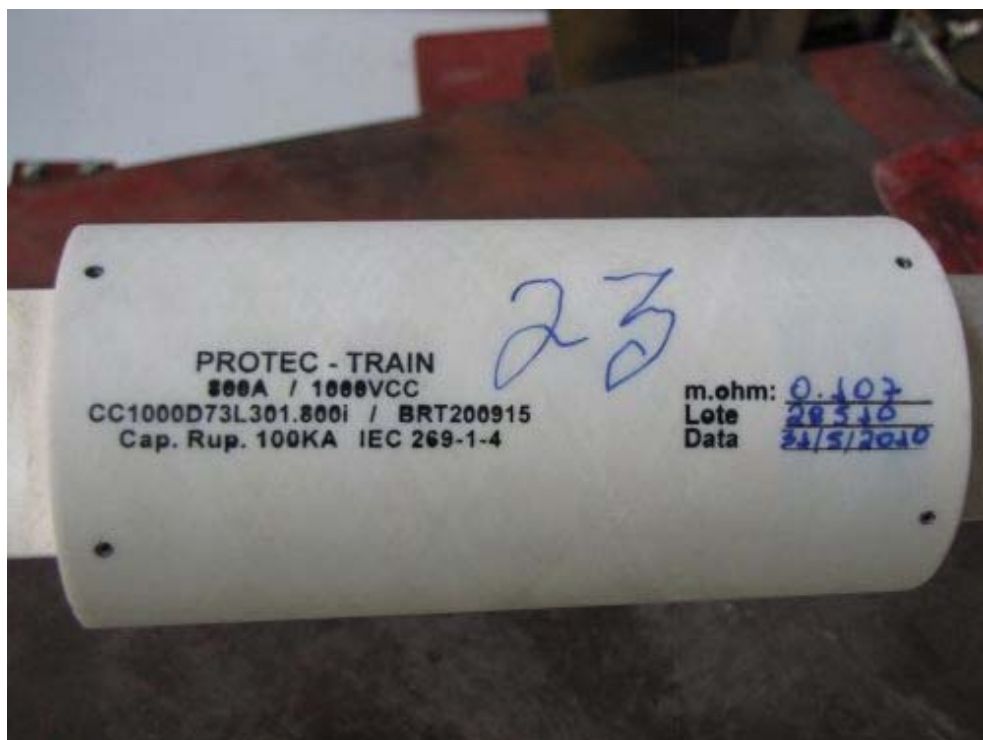
Photo 12: Test object No. 23 after test
